Influence of Geological Structure on Dam Behavior and Case Studies

Arash Barjasteh

Complex engineering projects including large dams require extensive reconnaissance. The study of geological relationships is therefore of major importance, with emphasis on the characteristics of the geological structures. Accordingly, geologic structure affects dam site and reservoir behavior in three ways: (1) its impact on the geomechanical properties of rocks; (2) the importance of geologic structures in the identification and assessment of karst hydrogeology; and (3) its role in seismotectonic and seismic risk analysis of dam projects. Site geology and availability of various geologic data obtained from site investigation are key points in dam construction. Geological structure plays an important role in dam site geology and imposes major limitations on dam behavior during and after construction stages. This role has its own effect on major subjects such as: morphotectonics of rivers; geotechnical properties and engineering geology of dam sites; and hydrogeology of dam abutments and reservoir. The variability and complexity of geological structures regarding their tectonic situation result in

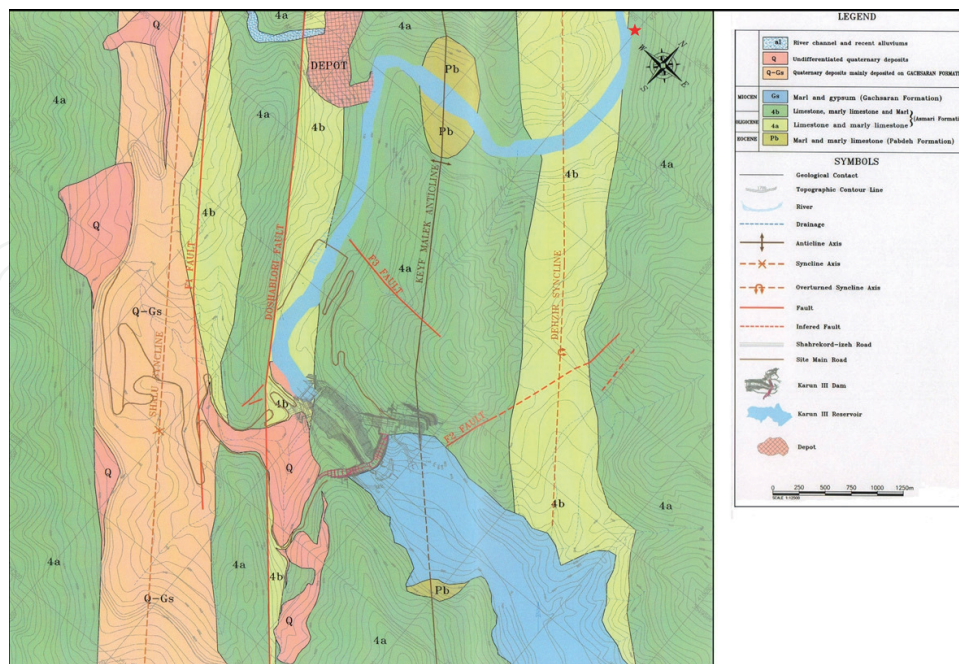
Figure 9. Geological map of the dam site area. Red star is the location of Abol-Ghasem Spring [36].

Another challenging subject in the dam region is the presence of Abol-Ghasem Spring downstream of the dam site. It is located at about 2.5 km downstream of the dam site, near the right bank of the Karun River (**Figure 9**). Its water was recharged by Lapeh anticline karstic aquifer, before impounding with varying seasonal discharge nearly between 0.5 and 1.5 m³/s, and increased to about 2.5 m³/s after reservoir impoundment. Additionally, another seasonal spring about 70 m downstream of the Abol-Ghasem Spring was changed to a permanent one after the dam impounding. It seems that the both limbs of Keyf Malek anticline are potential paths for seepage equally [34]. Karstification of the northeastern limb of the Keyf Malek anticline along with thrust faulting intensified the seepage at the spring. The presence of an overturned syncline between the two anticlines indicates intense tectonic compression in the region that could result in dense fracturing in the existing two anticlines. Transverse faults cut across the anticline that is evident through sharp and sudden change of Karun River course downstream the dam site might facilitate the occurrence of springs.

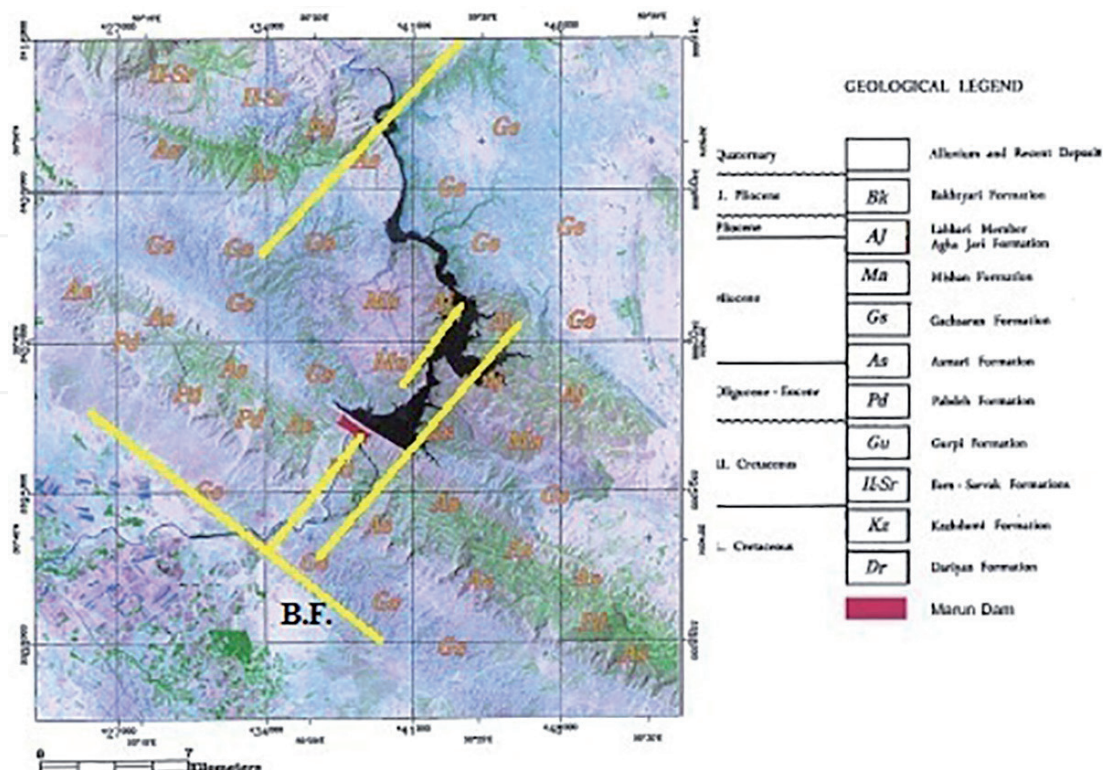
Figure 15. A general layout of Marun dam and appurtenant structures [39]. BF is Behbahan thrust fault.

The first and prominent problem encountered in Marun dam site was leakage through a diversion tunnel named as second diversion tunnel during the first impounding. Immediately after impoundment, considerable leakage was observed in the pressure tunnel (**Figure 16**) and efforts to open the stop logs failed. At the same time, an embankment was constructed and subsequent grouting controlled the leakage in the pressure tunnel. Old karst channels along a vuggy zone cut by the second diversion tunnel were reactivated and leakage occurred [39]. The total amount of water leakage through the left bank of Marun dam was about 10–15 m³/s. The unlined second diversion tunnel had a key role in connecting reservoir with karst conduit system.

The embankment was overtopped with increasing water elevation, and considerable leakage of up to 7 m³/s occurred from weak zones upstream of the plug. The major flow of approximately 4.5 m³/s was from two large solution channels and leakage around the concrete plug.

The remaining flow was from the access tunnel and the grouting adit ($2.3 \text{ m}^3/\text{s}$). The total amount of water leakage through the left bank of Marun dam was about $10 \text{ m}^3/\text{s}$. The water entered the fracture system upstream of the plug and passed along the fissures, washed out the marls interbeds forming large cavities. These are master cross joints traversing the dam site rocks from upstream to downstream. Water was leaking into all tunnels and the dam, and all springs received their water from the same fissure as was reported [39]. In fact, these are fracture swarms as was defined above indicating the intense fracturing surrounding faults or narrow zones with a very high frequency of fractures. These major features are major conduits for fluid flow in the subsurface at some stage that is very favorable for karst development. This is almost similar to the karstic features mentioned for Karun-1 dam (abovementioned) although it is almost visible that karstification is developed more and complete at the Marun dam site. Here, the general trend of fracture swarms is parallel to the general direction of the maximum compressive stress in the Zagros Fold Belt that produced tension-induced, open fractures resulting in significant secondary permeability to the rock. Intersection of longitudinal fractures (vuggy zone) in the Khaviz anticline with transverse fractures (fracture swarms) amplified permeability of the rock and simplified water leakage through the left abutment during the first reservoir impounding. It is very probable that seepage paths were formed along the fracture swarms parallel to the second diversion tunnel.

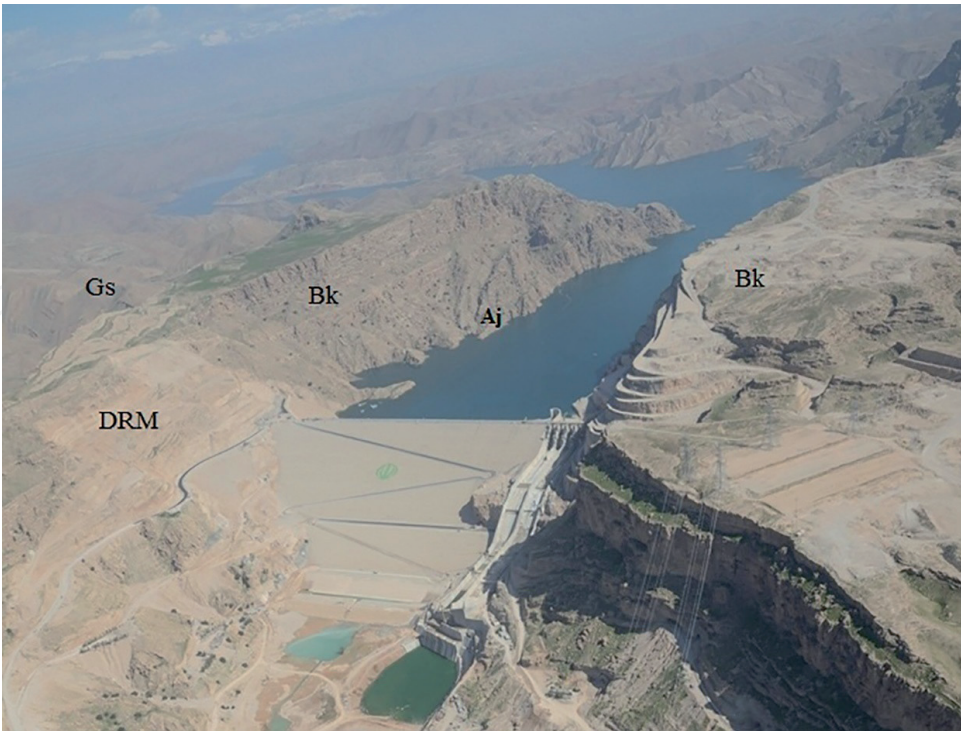
Figure 17. An upstream (eastward) view of Gotvand dam site and the outcropped formations; Bakhtyari (Bk), Agha-Jari (Aj), and Gachsaran (Gs). DRM is displaced rock mass.

As mentioned above, one of the challenges at Gotvand dam is instability of the dam abutments [42] and its reservoir banks [44]. The dam abutments include considerable volumes of dislocated rock mass of Bakhtyari formation. This is more critical in the right abutment as the rock mass is highly disturbed and deformed (DRM) and apparently illustrates a rock topple (**Figures 17 and 20**). On the other hand, the rock mass in the left abutment shows evidence of a rock slide. The DRM area is specified by extensive development of joints and cracks and its

extent along the dam axis was estimated between 150 and 200 m [45]. Consequently, water seepage was considered as an extra problem in the right abutment. Lugeon tests in this zone indicated values more than 60 due to the extent of fracturing. The prevailing hydromechanical behavior of the rocks at this abutment was dilatation and washout based on geotechnical investigations [44, 45].

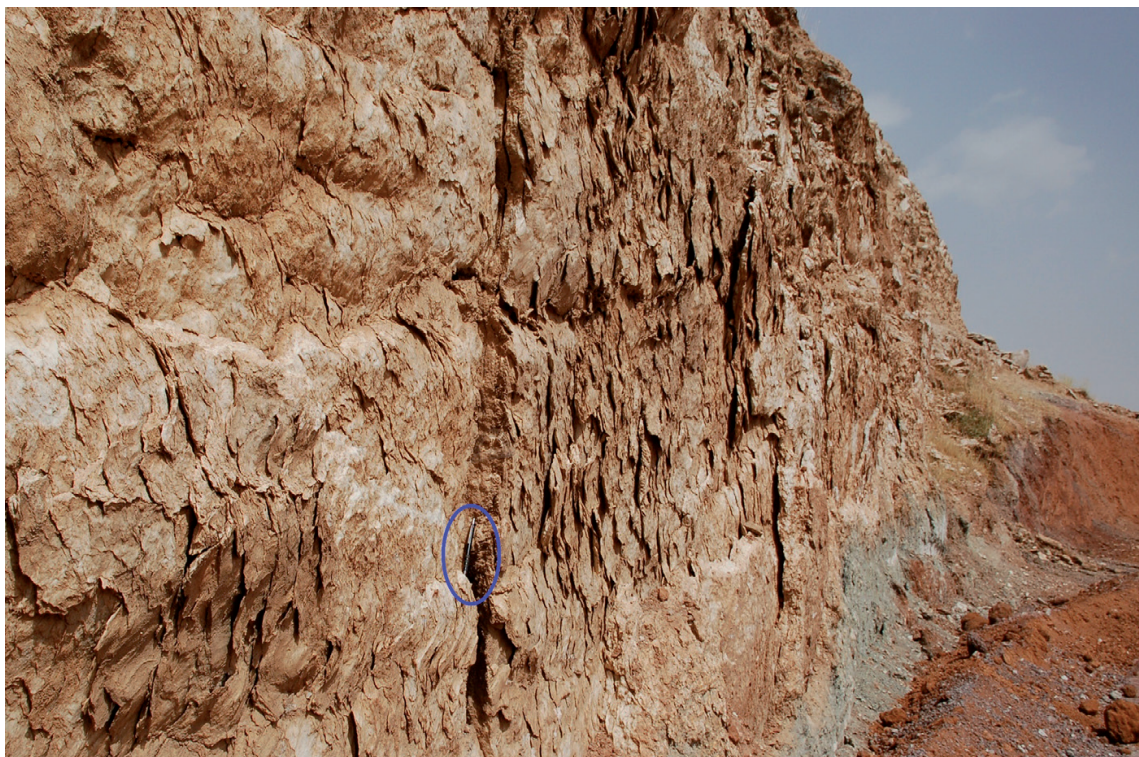
Figure 19. A close view of Pir-Ahmad Fault in the northern side of Kuh-e Reshteh anticline.
